SPRING/SUMMER 2000
VOLUME XXVI, Nos. 1&2

THE
HISTORIC HUNTSVILLE QUARTERLY
OF LOCAL ARCHITECTURE AND PRESERVATION

THE 1939 TENNESSEE VALLEY
ARCHITECTURAL PHOTOGRAPHY
OF

FRANCES BENJAMIN JOHNSTON

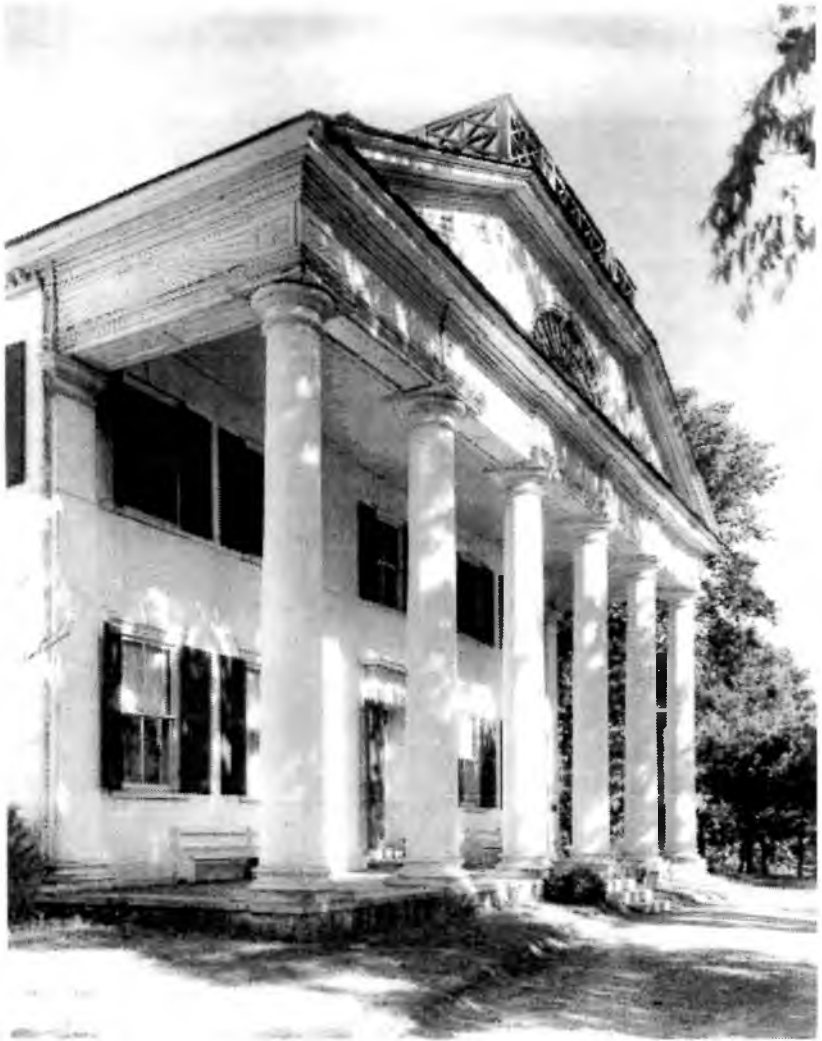
Fig. 1 Portico, 1840s, at LeRoy Pope House. Huntsville, Madison County.

One of Johnston's more successful Tennessee Valley images shows a building that is architecturally distinguished and historically significant. Johnston's image of it is captivating. It shows the elegant portico on the west side of the *LeRoy Pope House* in Huntsville (Fig. 1, page 10). Begun in 1814 by the founder of Huntsville, Colonel LeRoy Pope (1765-1844), the initial portion of this large residence may be the oldest brick house in Alabama. The portico, a later addition designed by Huntsville architect George Steele in the early 1840s, features six substantial Tuscan columns with an unusual truncated pediment topped by a balustraded deck. Above the columns, on the face of the tympanum, is a reeded sunburst motif that is repeated on the front and sides of the frieze below.

to photograph its facade with the light coming from the left (Fig. 5, page 17). In the early afternoon, she shot the *LeRoy Pope House* in full sunlight (Fig. 1, page 10) and then the *Bibb-Bradley-Beirne House* (Fig. 7, above) in the lengthening shadows of the late afternoon sun.

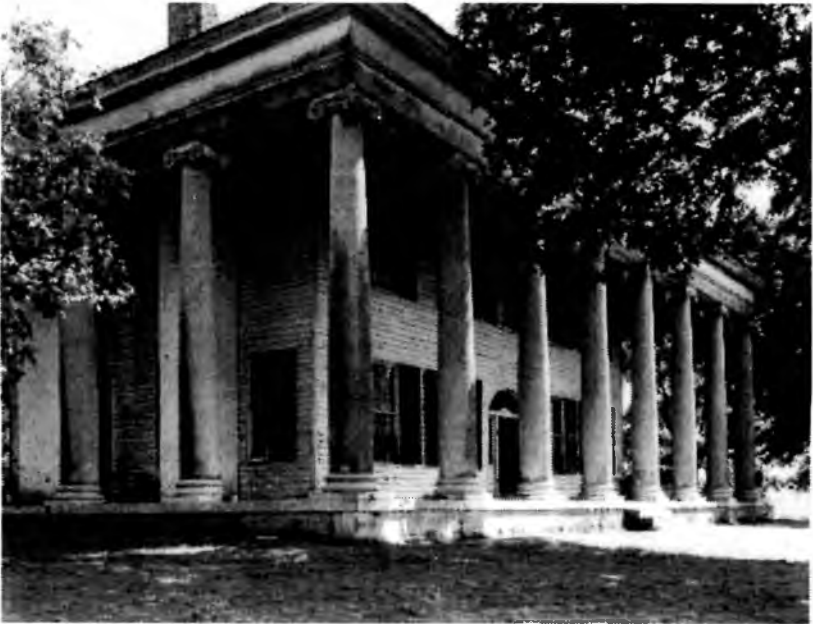
Fig.2 The Forks of Cypress. 1830. Formerly near Florence, Lauderdale County. Struck by lightning and burned June 6, 1966.

Among the now-gone Tennessee Valley buildings photographed by Johnston, the most grievous loss is *Forks of Cypress* (Figs.2 & 3, pages 12 & 14) north of Florence. It burned in June 1966 after being struck by lightning; ruins of its massive columns survive. An extraordinary building, the *Forks of Cypress* was probably designed by William Nichols and built about 1830 for James Jackson (1782-1840), a planter and breeder of nationally known race horses.

Johnston was clearly impressed by *Forks of Cypress* when she photographed it on May 14, 1939. She made ten photographs of it: the most views she made of any Alabama building. Seven are exterior shots, providing enlightening images of the impressive Ionic colonnade around the house. Three interior views show the elegant Federal detailing of the hall staircase and two graceful mantelpieces.

History: House built circa 1830 for James Jackson (1782-1840), probably designed by William Nichols. Jackson, born in Ulster, was a planter and nationally known horse breeder. Photographed May 14, 1939, by Frances B. Johnston. Struck by lightning and burned June 6, 1966. "Only example in Alabama of dwelling with peristyle colonnade and unique in America in such use of Ionic order." Gamble p. 251. Ruins of the columns survive.

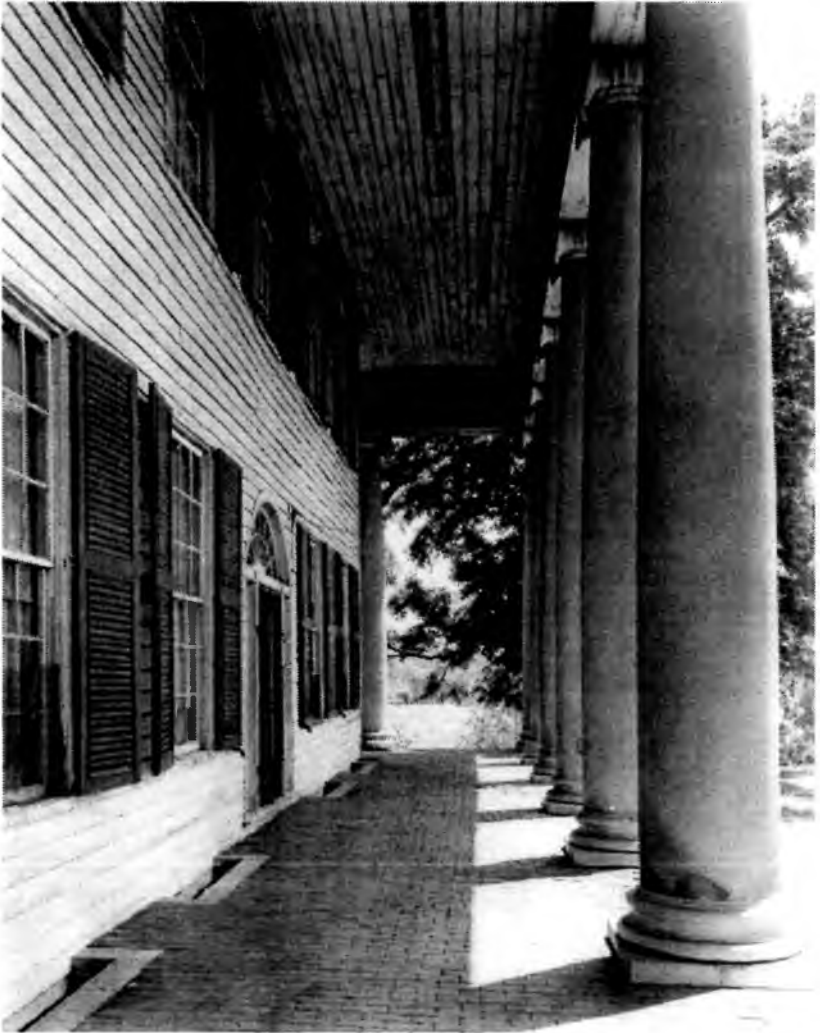
*Fig.3 Porch. **The Forks of Cypress.** 1830. Formerly near Florence, Lauderdale County. Struck by lightning and burned June 6, 1966.*

Perhaps the most evocative exterior view Johnston made at *Forks of Cypress* (Fig.3, page 14) looks along the porch of the main elevation. This photograph, too, is an exemplary image, distinguished by an artful composition of architectural form and pictorial pattern. At the left, it shows shuttered windows and the double-door main entrance, a view of distant foliage in the center, and the bases and massive columns of the main elevation colonnade at the right. The pattern of contrasting sunlight and shadow on the brick pavement neatly echoes

the rhythm of architectural elements on the left. These elements are nicely balanced in an elegant asymmetrical composition that effectively conveys the grandeur of this lost masterpiece. Similarly, in her oblique view of the main elevation (Fig.2, page 12), notice how she located her camera to show sunlight along the right edges of the columns.

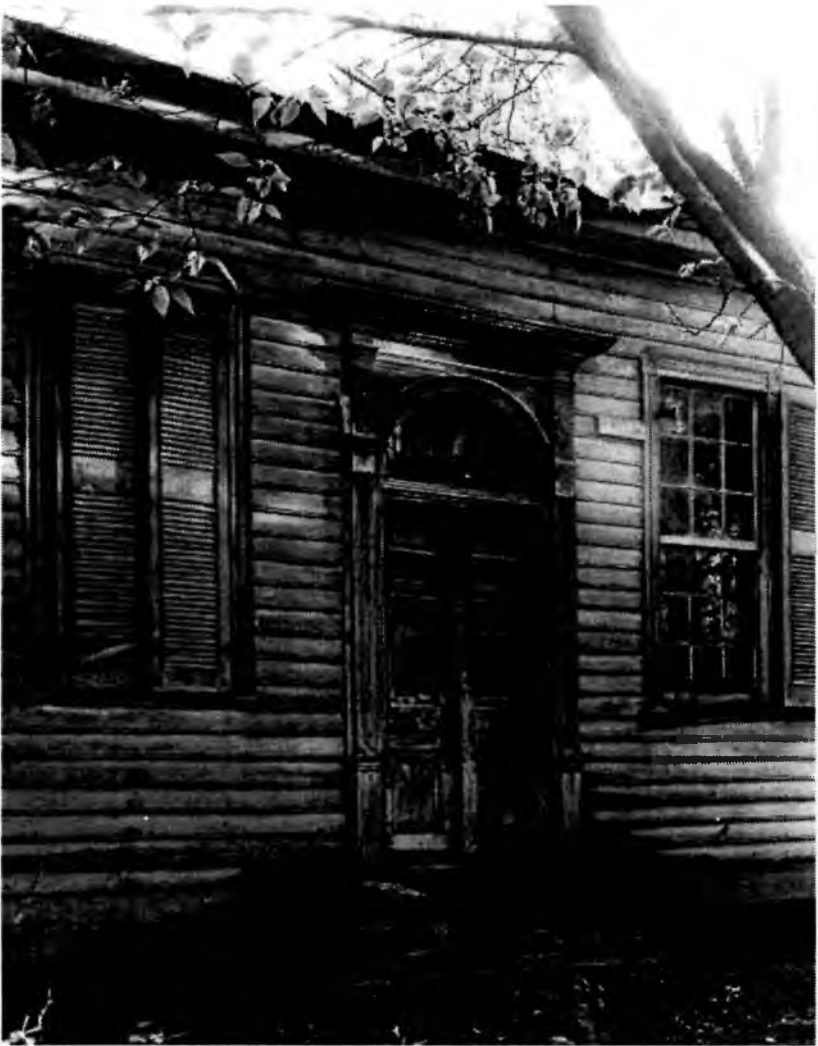
Fig.4 Entrance. W.W. James House, circa 1825. Formerly near Courtland, Lawrence County. Demolished circa 1940.

Such a view is seen in Johnston's image of an exceptional Adamesque fanlight doorway on a small Federal style home formerly in Courtland in Lawrence County, the W.W. James House (Fig.4, page 16). This view features an unusually detailed doorway of exceptionally sophisticated design. The paneled double doors, engaged side pilasters, carved sunburst motifs, and heavily molded cornice required considerable woodworking expertise. This doorway might be a demonstration piece, to show the skills of the home's initial owner Westwood Wallace James (1795-1866), who was a cabinetmaker from Virginia. Built about 1825, the house was sadly neglected in 1939, as seen in the missing stairs and shutter. It was demolished circa 1940, shortly after Johnston shot this telling detail of an exceptionally fine architectural element.

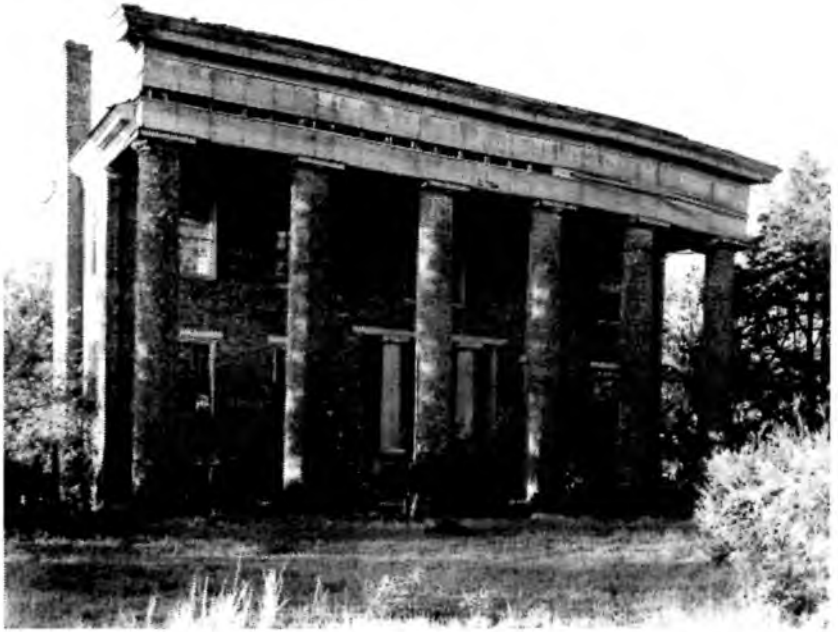
Fig.5 David Wade House, circa 1840. Formerly near Huntsville, Madison County. Demolished 1940.

Johnston addressed a similar challenge in her view of a lost Madison County home, the David Wade House (Fig.5, page 17), formerly north of Huntsville. Built about 1840, it too was deteriorating when she photographed it in May 1939. (It was subsequently demolished in the late 1940s.) Here, Johnston selected a distant overall view in order to include, and emphasize, the most distinctive architectural feature of the house, the massive oversized entablature above the columns. Even though the long gap across the wooden fabric shows that it had obviously lost much of its original detail, Johnston's image conveys a sense of its original imposing grandeur. She achieved this effect by positioning her large camera near the building so that her lens pointed upward at a moderately steep angle. In the resulting image, the large entablature dominates the scene, especially because its highlighted face contrasts so strongly with the dark shadowed walls behind the porch beneath it.

Johnston's schedule for shooting her views of four Huntsville buildings can be recreated, based on the light patterns seen in the views combined with knowledge of the direction faced by surviving buildings. On May 10, 1939, she apparently left Decatur early in the morning to drive to Huntsville, going first to the *David Wade House*

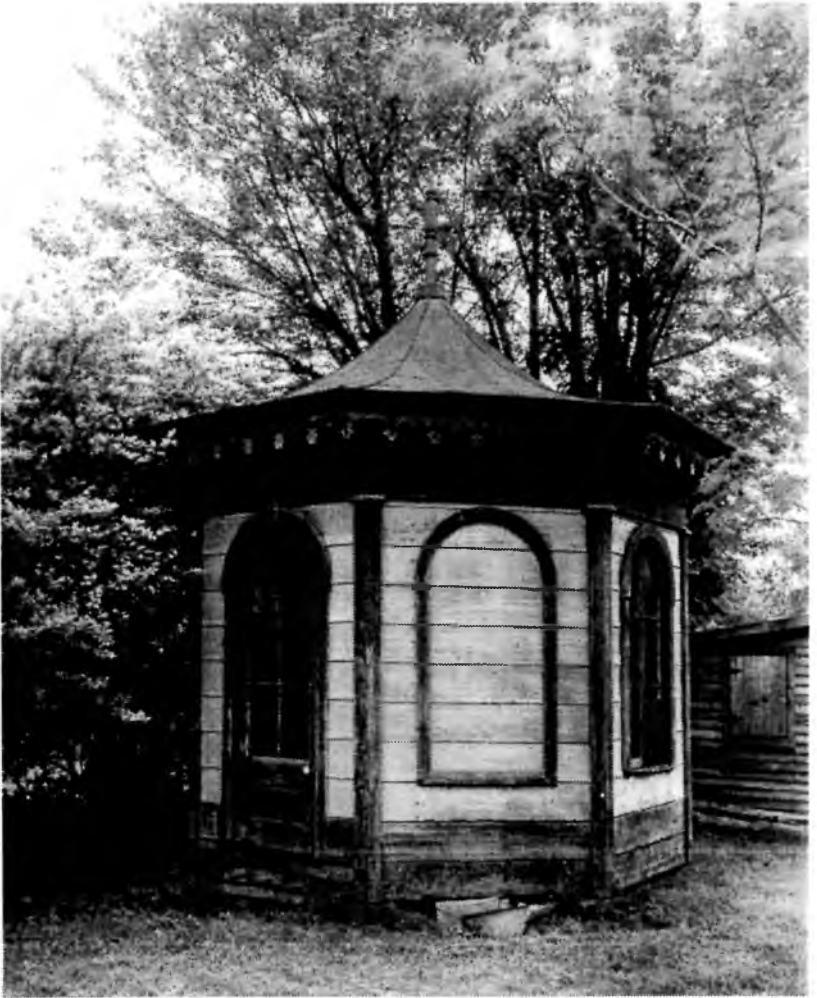
*Fig.6 Office, 19th century, at **Beaty-Mason House**, Athens, Limestone County.*

One unusual building photographed by Johnston exemplifies a type of building that is often lost—the small service building. Today, when viewing an imposing historic house preserved from centuries past, it is easy to ignore that it may be the sole survivor of a formerly large domestic complex of many buildings. A surviving big house was often originally the heart of a galaxy of numerous small service buildings, typically one-story structures, each with a single function.

When the function is no longer needed, the service building is rarely maintained, let alone preserved. Most are torn down. We know them by familiar names—outhouse, spring-house, well-house, icehouse, kitchen—but these small buildings are becoming increasingly rare to experience first-hand.

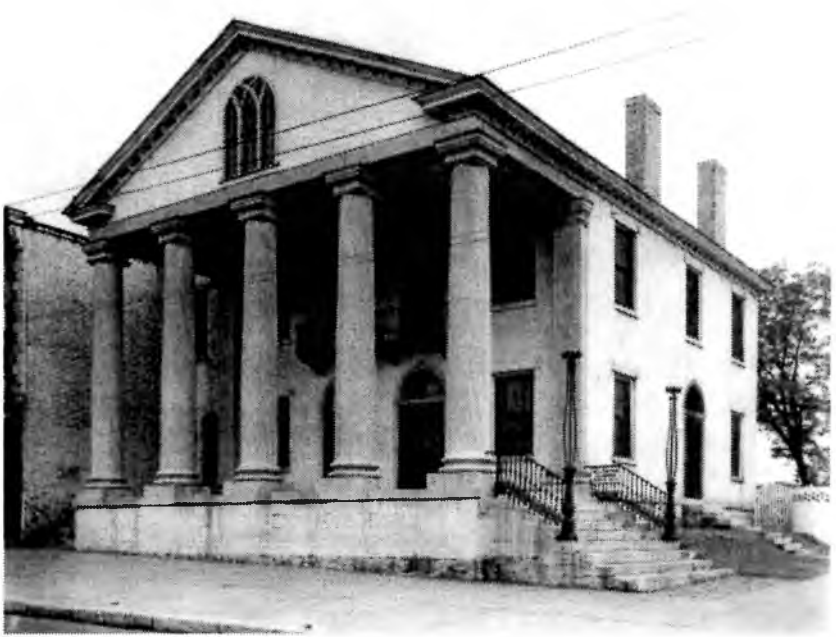
Fig.8 Decatur Branch, State Bank of Alabama, circa 1834-1836. Decatur, Morgan County.

Unusual materials and unique design elements distinguish the *Decatur Branch, State Bank of Alabama*, built about 1834-36 (Fig.8, page 23). Granite, rarely used in Alabama buildings, is the fabric of the impressive columns and the window transoms and sills. Also unusual is the 5-column portico. It is odd, literally and figuratively. An even number of columns—2, 4, 6, 8—is the norm for classic revival porticos. Also unusual are the square capitals (usually round) and the atypical arched window with Gothic tracery in the tympanum. This 1939 view documents a historic condition since changed; the arched window, probably a later addition, was removed during the 1979-80 reconditioning of the building.

Johnston's view was apparently taken on an overcast day, evident by the subdued lighting and the absence of highlights. In making the view, her camera placement may have been constrained by the building's urban setting, as suggested by the close cropping of the large neighbor building at the left side of the view. Notice also how she sited her camera to de-emphasize the utility wires by having one set overlap the tympanum rather than cutting across the columns below.

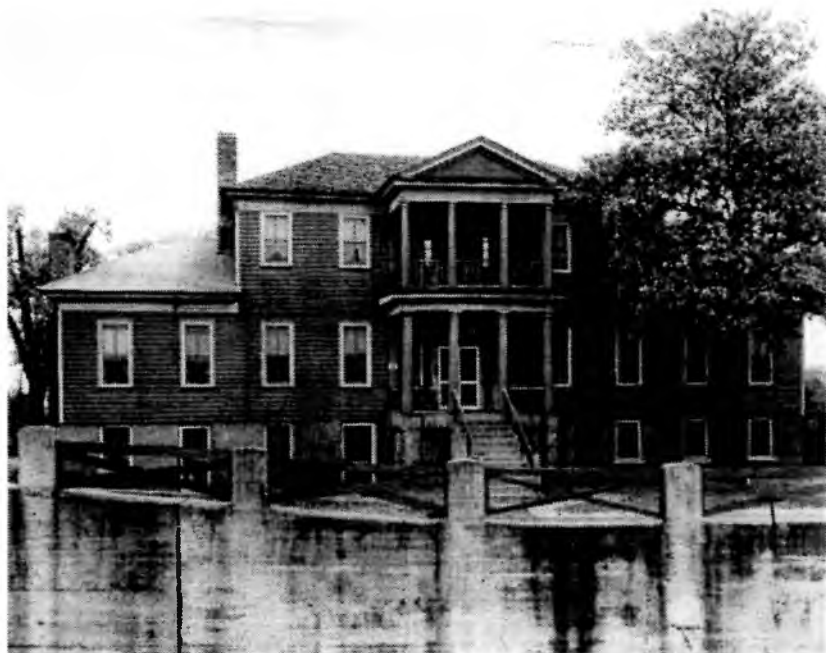
Fig.9 Dancy-Polk House, circa 1829. Decatur, Morgan County.

A different urban challenge is confronted in Johnston's view of the *Dancy-Polk House* (Fig.9, page 25). Built circa 1829 for Colonel Frank Dancy, this wood frame structure on a high brick foundation is one of the oldest surviving buildings in Decatur. An unusual profile—a two-story central core flanked by one-story wings—and a Palladian-style double porch on the east elevation are prominent features of this building. However, the best views of these features are severely constrained by a deep railroad cut constructed near the building after it was completed. The railroad cut dominates the foreground of any overall view of the east side of the house and the Palladian porch. Another impediment was a large tree to the right of the porch.

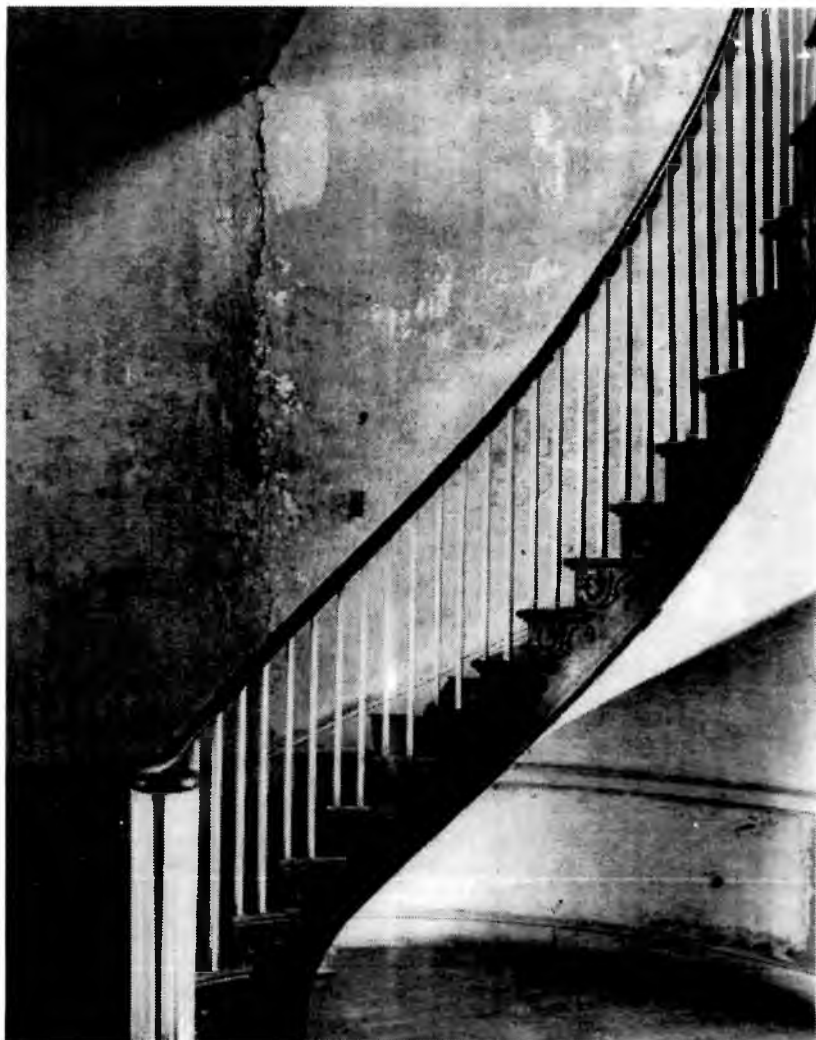
Fig.14 Spiral Stairway. Belle Mina, circa 1826-35. Near Mooresville, Limestone County.

Belle Mina has exceptionally fine Federal period woodwork, exemplified here by the stair's intricate scrolled endpieces. In Johnston's image the carefully composed vertical format emphasizes the elegant shape of the stairway, spiraling upward to the right. It is further enhanced by the soft lighting, probably obtained by opening the wide main entrance door at the opposite end of the main hall (Fig. 13, page 29).

Another challenging factor in making interior shots is seen in this view. When fabric or paint has deteriorated near a primary feature, it may be difficult to compose an interior view to exclude the distracting blemish. Here, the peeling paint on the wall would have been hard to exclude from any view of this staircase.

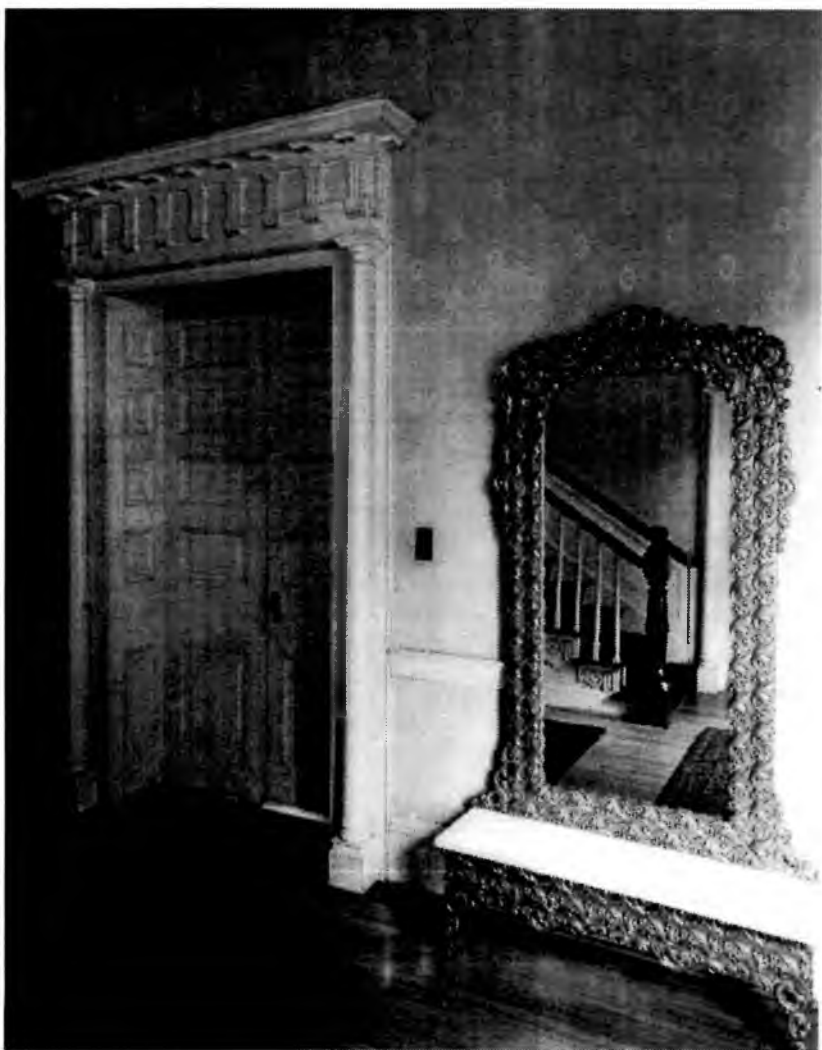
Fig. 17 Doorway, mirror, and reflection. Rhea-Burleson-McEntire House, circa 1836. Decatur, Morgan County.

At the *Rhea-Burleson-McEntire House* in Decatur, Johnston made only interior detail views. Built in 1836 for John Sevier Rhea, grandson of Tennessee Governor John Sevier, this grand house is located on the south bank of the Tennessee River. It has exceptionally elaborate interior woodwork, as seen in Johnston's carefully arranged view of a doorway and hall mirror (Fig. 17, page 35). This view in the main hall shows one of the most sophisticated Federal style doorways in the Tennessee Valley, featuring paneled double doors framed by an impressive engaged columnar architrave. Notice the reflection in the gilded mirror bench at the right of the view. Its reflected image shows the foot of the staircase, dado paneling, and carved doorway on the opposite side of the hall.

Imagine the amount of time needed to set up this dense complex view of doorway, mirror, and reflection, and to wait for the optimum moment when light would be streaming through the main entrance door (out of the view) at the right. This detail interior view is shot in vertical format, as seen elsewhere in situations where Johnston wanted to focus viewer attention on significant architectural elements. (The vertical format is used in three of the four interior views she made of the *Rhea-Burleson-McEntire House*.)

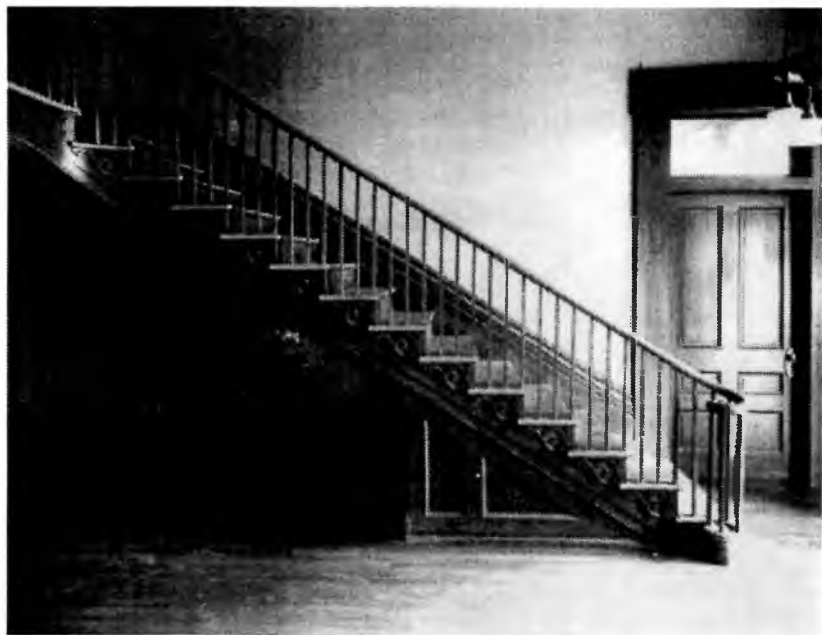
Fig.19 Flight of stairs. Barton Hall, circa 1847-49. Near Cherokee, Colbert County.

Johnston's two interior views of *Barton Hall* both show the unusual stairway that dominates the main hall. The more effective view of this complex structure is a partial view that focuses on a single element, a flight of stairs (Fig. 19, page 38). The view features one of the flights that rise from each end of the main hall. They ascend in a series of double reverse flights connected by bridge-like flying landings. This remarkable structure is challenging to photograph in its entirety in any condition. Using only available natural light, Johnston's views convey a convincing sense of its complexity and unique architectural character.¹²

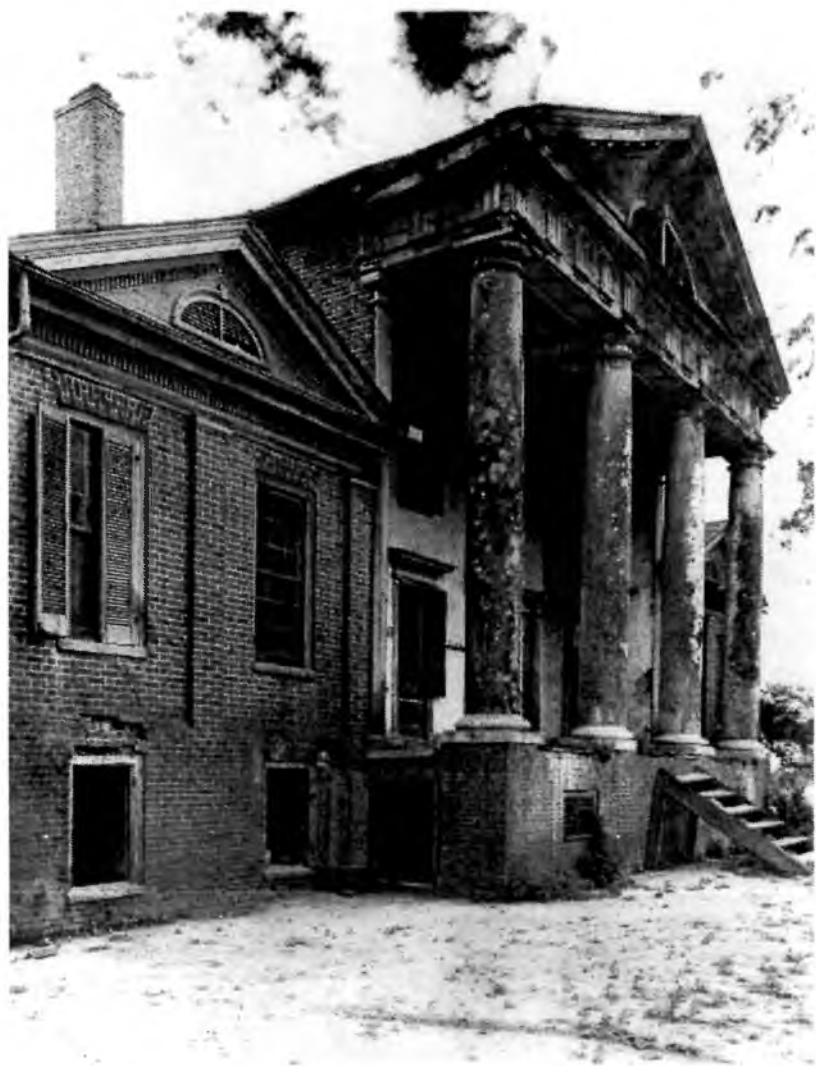
Fig.20 Saunders-Goode-Hall House, circa 1830-35. Near Town Creek, Lawrence County.

The *Saunders-Goode-Hall House* is located north of Town Creek in Lawrence County. It was built in 1830-35 for the Rev. Turner Saunders, planter and Methodist minister from Brunswick County, Virginia. It has been cited as an "outstanding expression in Alabama of Jeffersonian classicism exhibiting Palladian influence."¹³ The

Saunders-Goode-Hall House is constructed of brick in a three-part H-shape plan, with a central two-story pavilion flanked by one and one-half-story wings.

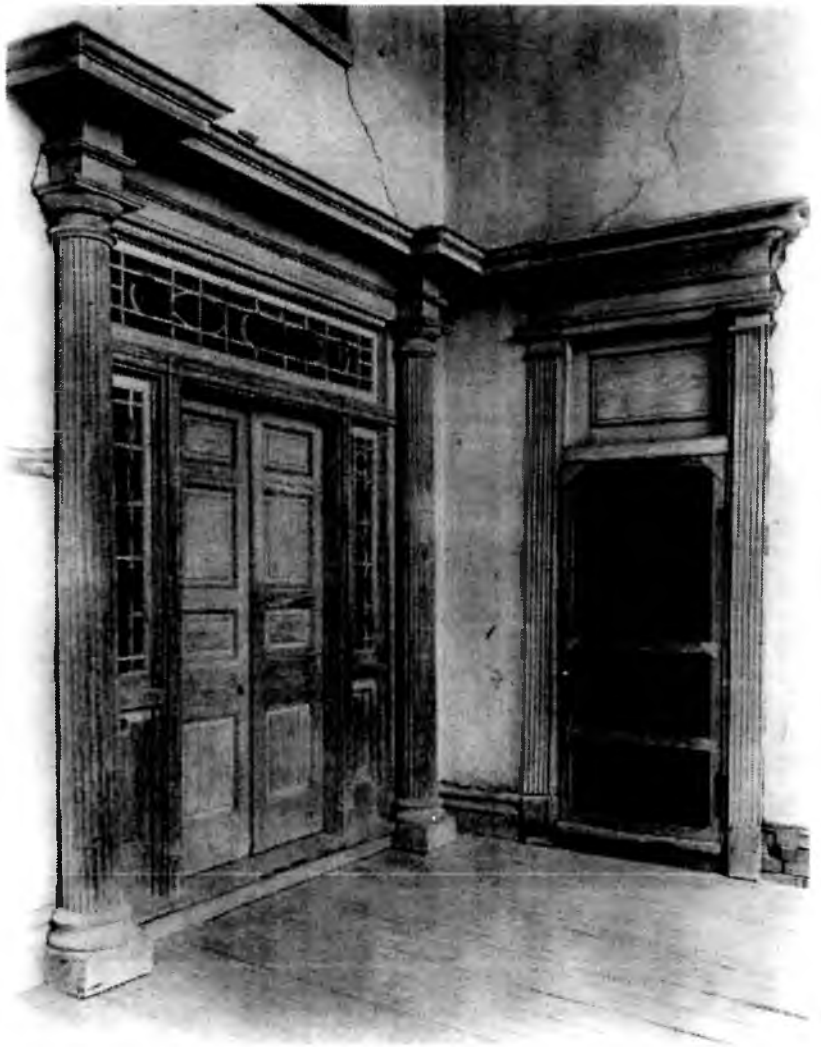
Fig.21 Two doorways on portico porch. Saunders-Goode-Hall House, circa 1830-35. Near Town Creek, Lawrence County.

The doorways in this view can be glimpsed between the portico columns in the overall view (Fig.20) on the facing page.
